# **TWA 800**

# **Accident Overview**

**Michael Collins**  
**Fuel Tank Safety Program Manager**  
**Transport Standards Staff, ANM-112**  
**[michael.collins@faa.gov](mailto:michael.collins@faa.gov)**

**November 5, 2001**

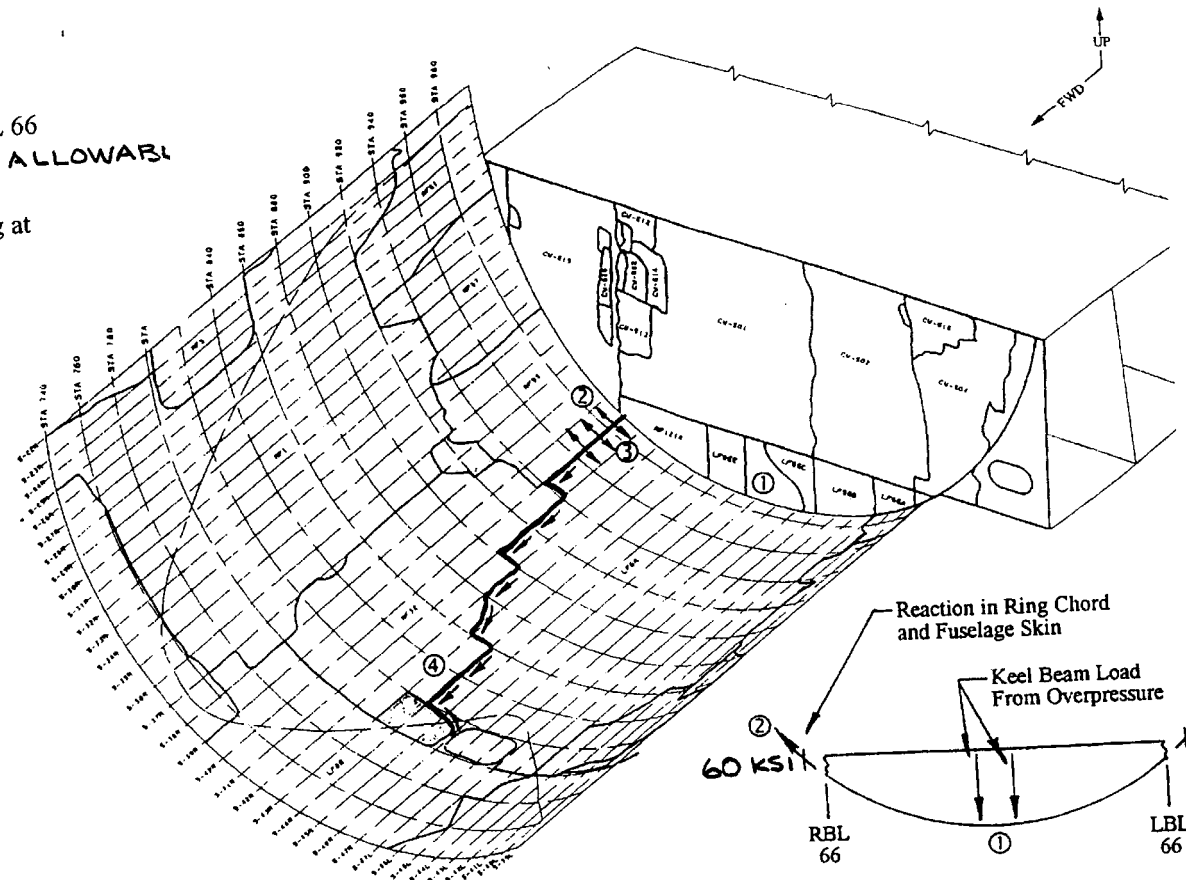
### Failure Initiation; Fuselage Lower Lobe

- ① Keel Beam overpressure related loading still present in lower pressure bulkhead (RELATED TO ASSUMED 25 PSI)
- ② Load reaction is concentrated in ring chord and adjacent fuselage skin at RBL 66 and LBL 66 where web has failed
- ③ Ring chord and adjacent fuselage fail in net tension at RBL 66 (S-40R) 60 KSI PREDICTED 55 KSI ALLOWABLE
- ④ Fuselage crack propagates forward to access door opening at STA 810

## Breakup Sequence

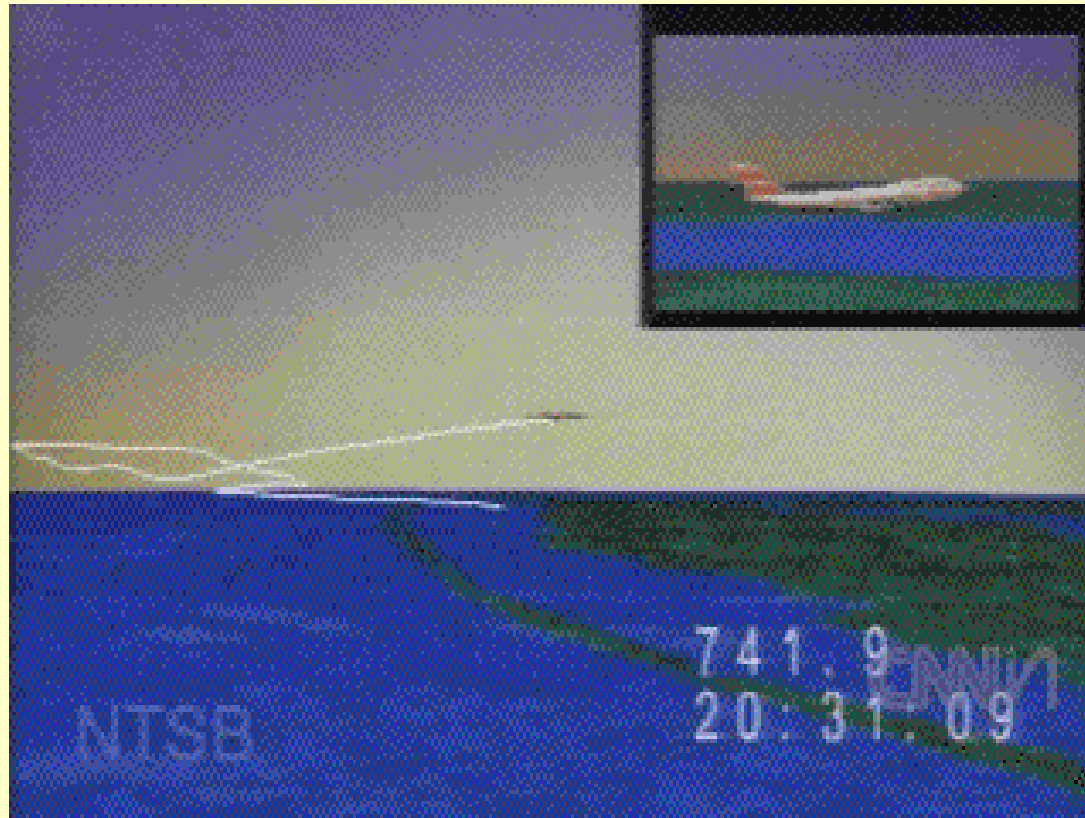
# TWA Flight 800 Fuel Tank Explosion July 17, 1996

Explosion of CWT resulting from ignition of the flammable fuel/air mixture in CWT. The likely ignition energy source was a short circuit outside of the CWT that allowed excessive voltage to enter CWT through FQIS wiring.
