Appendix 3.2: Eclipse Final Report

Introduction

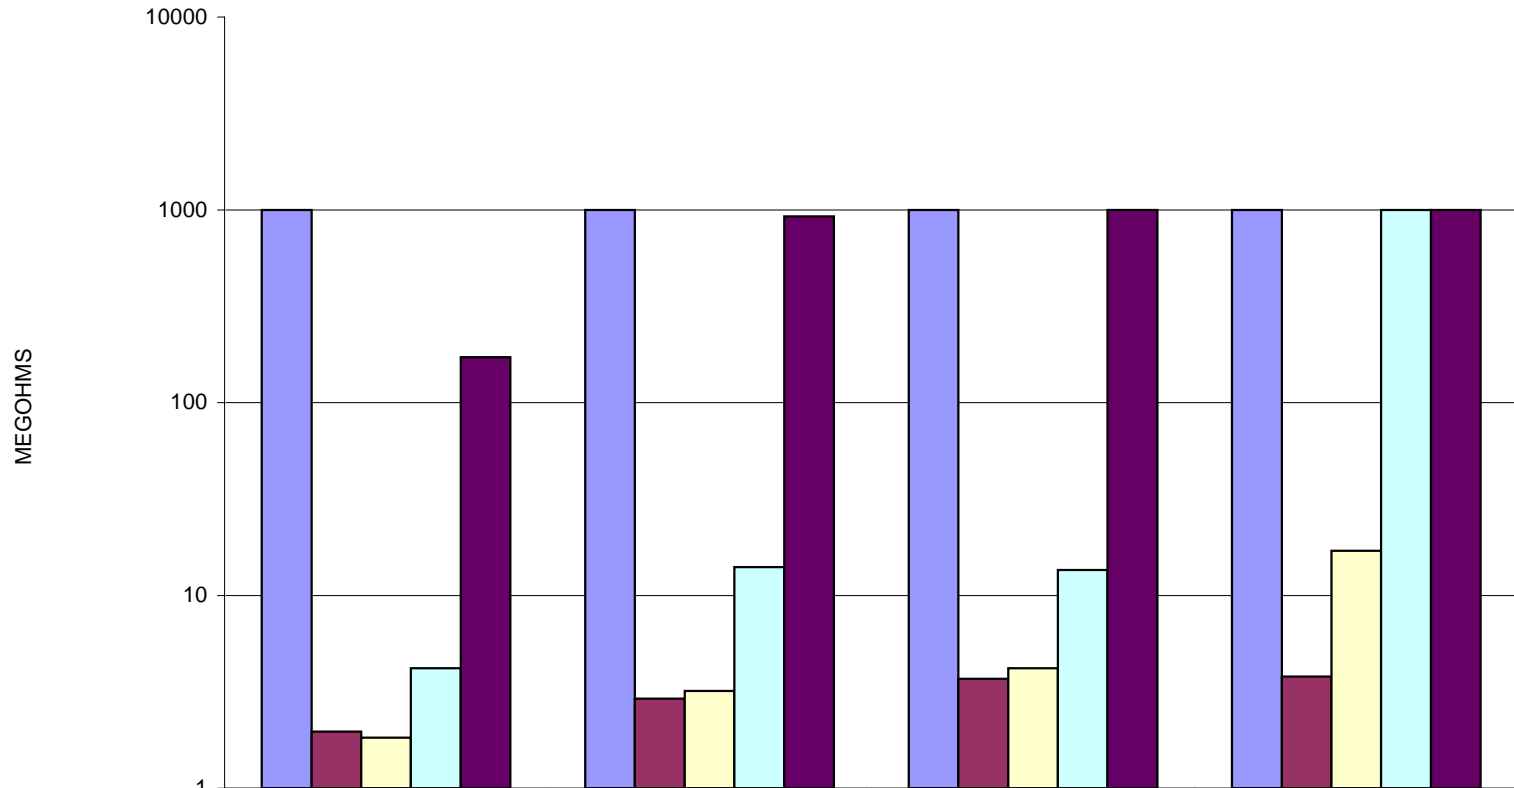
Figur

The three specimens in Table 3.2-1 exhibited rapid and large insulation resistance value changes when exposed to moisture. All three specimens exhibited the same basic pattern with respect to reaction time and insulation resistance value change. Figure 3.2-1 presents the insulation values measured and the time of measurement for the DC9-2 ENL specimen wire ID 47 when dry and moist. Wire ID 47 is a single conductor as are 35, 36, and 37 whereas 01 is a shield. The values are insulation resistance measurements made from wire ID 47 to each of the wire ID's of 01, 35, 36, 37. When the specimen was dry all measurements were at 1000 megohms, which is well above the 100-megohm minimum selected for anomalies. Upon the completion of the dry test run (9:24am) the moisture spray was applied and at 9:26am the initial moist specimen test run was completed, and subsequent test runs were completed at 9:56am, 10:26am and 11:06am without additional moisture applied. Referencing Figure 3.2-1 the very rapid and large decrease in insulation resistance is readily seen and also the slow recovery. The decrease in resistance occurred immediately while recovery to the 100-megohm level was over one hour for all of the subject wires.

DC-9(2) ENL MOISTURE RESULTS (WIRE ID 47)
