Chapter 2: Aircraft Visual Inspections

Six aircraft were subject to the detailed visual inspections described in Chapter 1 and Appendix 1.2, Sub-appendix 1.2.3. The first six sections of this chapter discuss the individual aircraft and inspections. The last section of this chapter presents the summary results of all the inspections. The database of specific findings has been presented to ATSRAC as a separate deliverable.

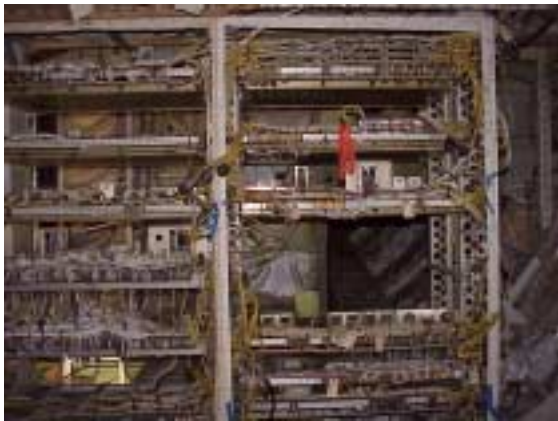
Figure 2-1: Boeing 747 Electronics Rack, EE Bay.

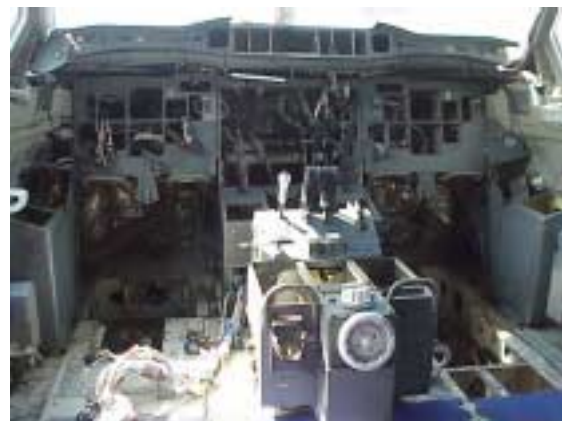
Figure 2-2: A300 Cockpit

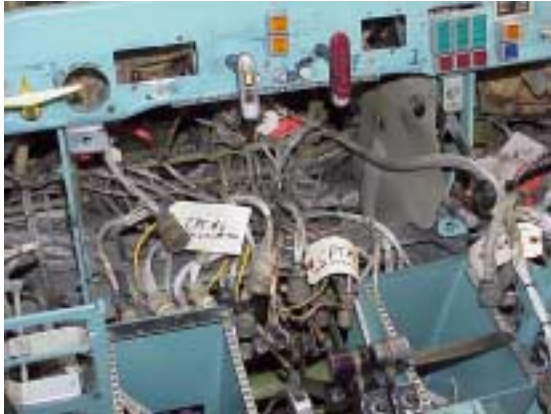
Figure 2-3: DC-9-1 Cockpit showing specimen and findings labels

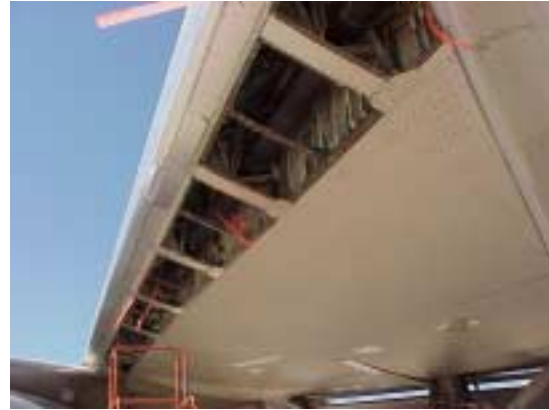
Figure 2-4: L1011 Wing Leading Edge with red tape demarcating specimens

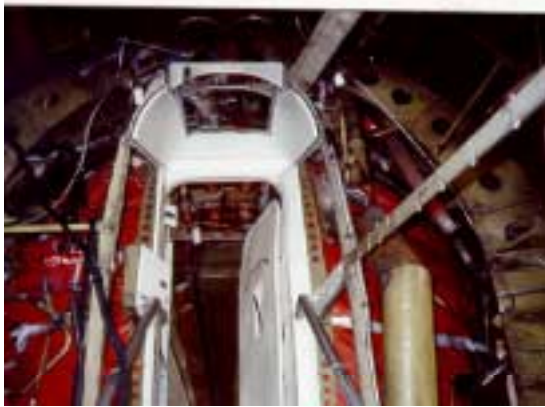
Figure 2-5: DC-9-2 Tail Cone looking forward to bulkhead

Overall, the inspection team found the general condition of the wire to be poor. In particular, the wire in the tail cone exhibited widespread cracking of the outer nylon jacket, discoloration of the wire inconsistent with staining, and apparent embitterment when flexed.

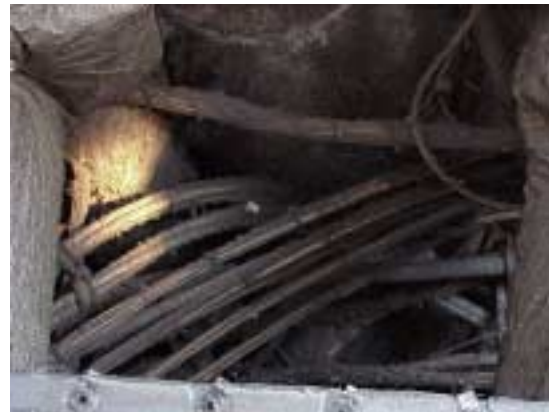
Figure 2-6: L1011 Under Floor Panels showing excessive dust and lint build-up.

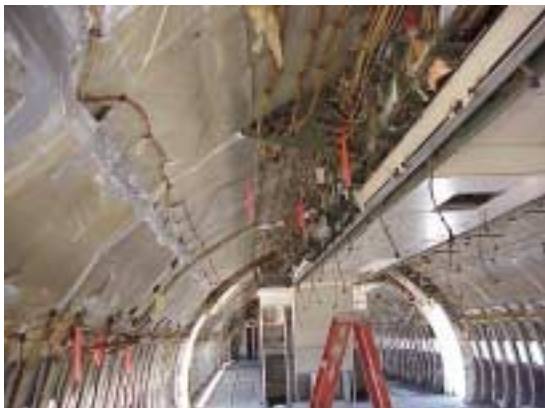
Figure 2-7: L1011 Main Cabin showing PCU cables

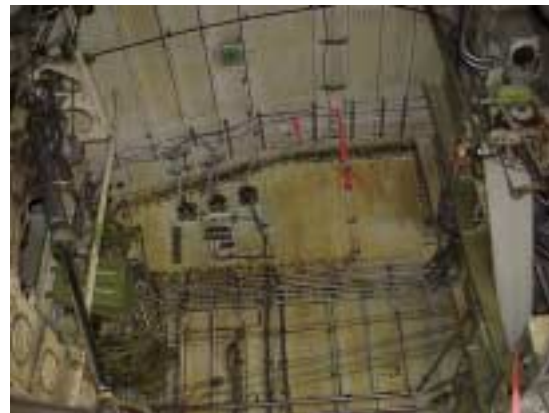
Figure 2-8: DC-10 Wheel Well
