## Chapter 3: Non-Destructive Testing

After completion of the detailed visual inspection by the working group, on-board nondestructive testing (NDT) was performed on-site on selected wiring harness of all six aircraft.<sup>1</sup> The NDT tests, Lectromec's Deltest and Eclipse's Automatic Test Equipment (ATE) insulation resistance and 2- and 4-wire tests, were specified and performed in accordance with the working group's intrusive inspection protocol (Appendix 1.2).

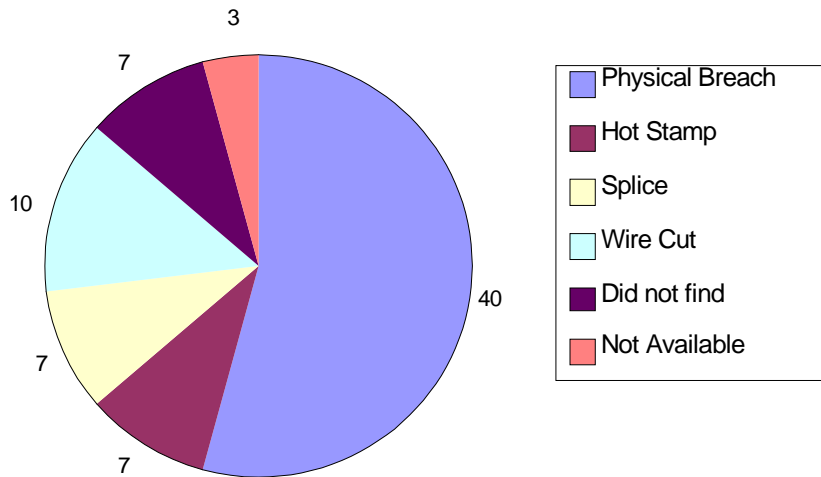
**Figure 3-1: Deltest Results by Condition Category. Not all conditions identified here are faults.**

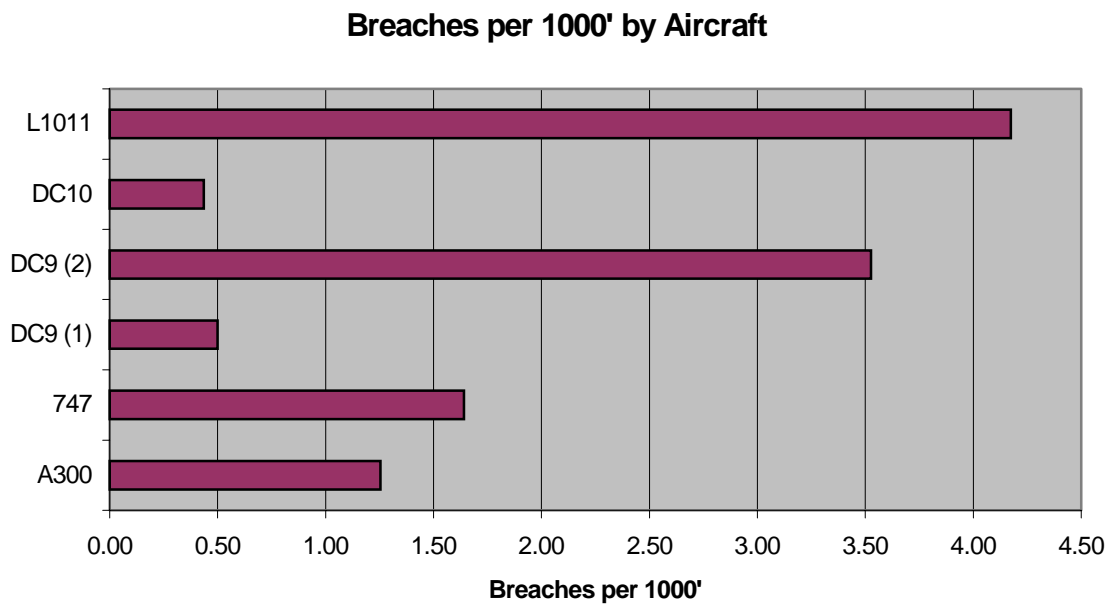
TYPE OF BREACH	A300	747	DC-9 (1)	DC-9 (2)	DC10	L1011	Totals
Physical Breach	9	7	2	7	2	13	40
Breach at Hot Stamp Area	1	4	0	0	0	2	7
Total Length Wire Tested (ft)	7974	6706	4001	1986	4588	3594	28847
<b>Total Breaches/1000 ft</b>	1.25	1.64	0.50	3.53	0.44	4.17	1.63

**Figure 3-2: Aircraft Specific Findings per 1000 feet of wire**

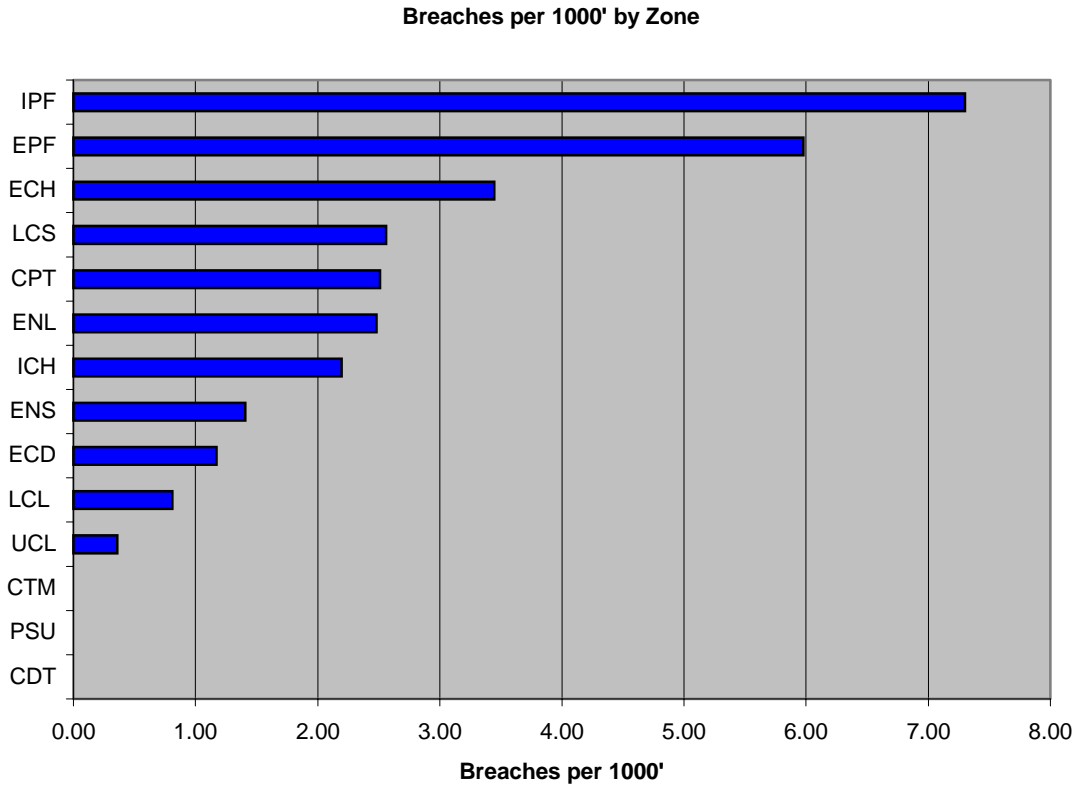
Figures 3-3 and 3-4 show the specimen-, and wire-type-specific findings per thousand feet of wire inspected.

**Figure 3-3: Specimen Specific Findings per 1000 feet of wire**

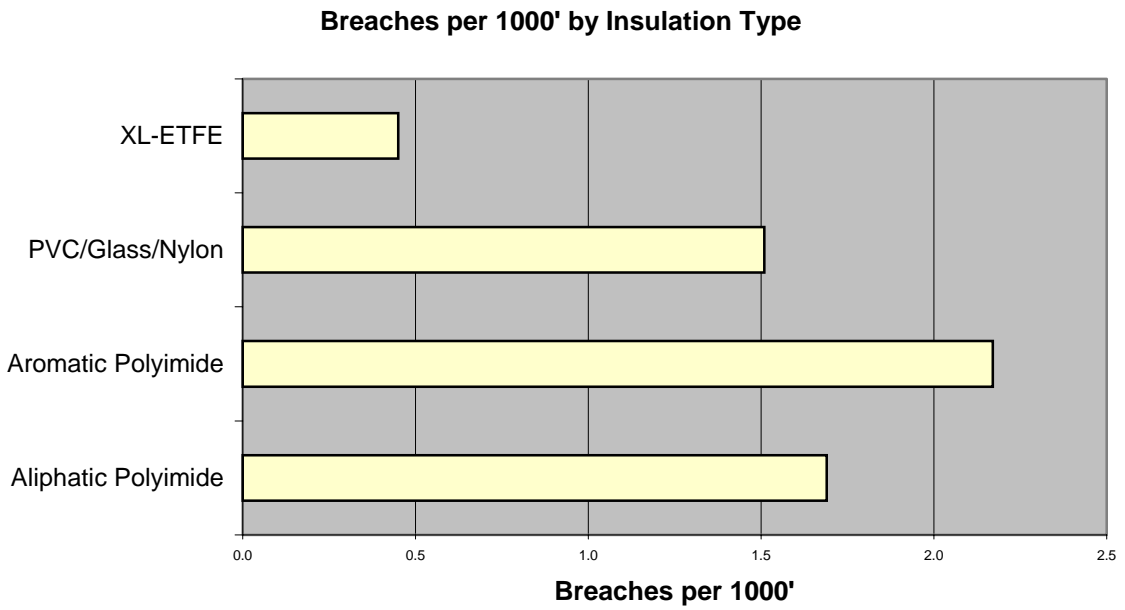
**Figure 3-4: Wire-Type Specific Findings per 1000 feet of wire**

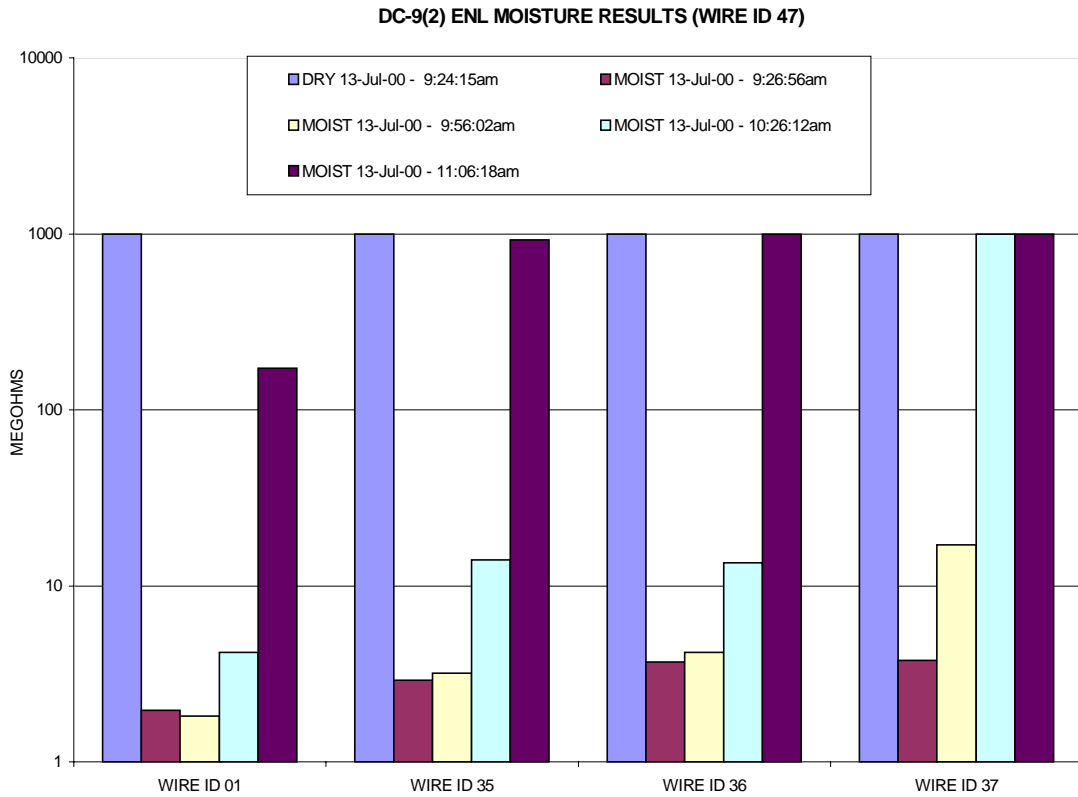
The moisture testing consisted of re-installing the wire specimens on Eclipse’s circuit analyzer set testing the dry samples and then spraying water onto the specimens. This was performed because of the variation of the results between the field and the re-test at the AANC. All six specimens passed when tested dry. Three specimens passed when first wet, that is, the insulation resistance was found to be within the limits of the wire. The specimens that passed were CTM from the DC-9 (2) and LCS and UCL2 from the 747. Three specimens failed when wet – ENL and ISTA from the DC-9 (2) and ECD1 from the 747. Note that both the ENL and ISTA specimens from the DC-9 (2) also had breaches found using the Lectromec DelTest™. The influence of moisture on the susceptible wire, and its dependence upon the ambient conditions is illustrated in Figure 3-5 below.

**Figure 3-5: Insulation resistance dependence on dry-wet-dry cycling of wires.**
