Chapter 4: Laboratory Testing

Experimental Description

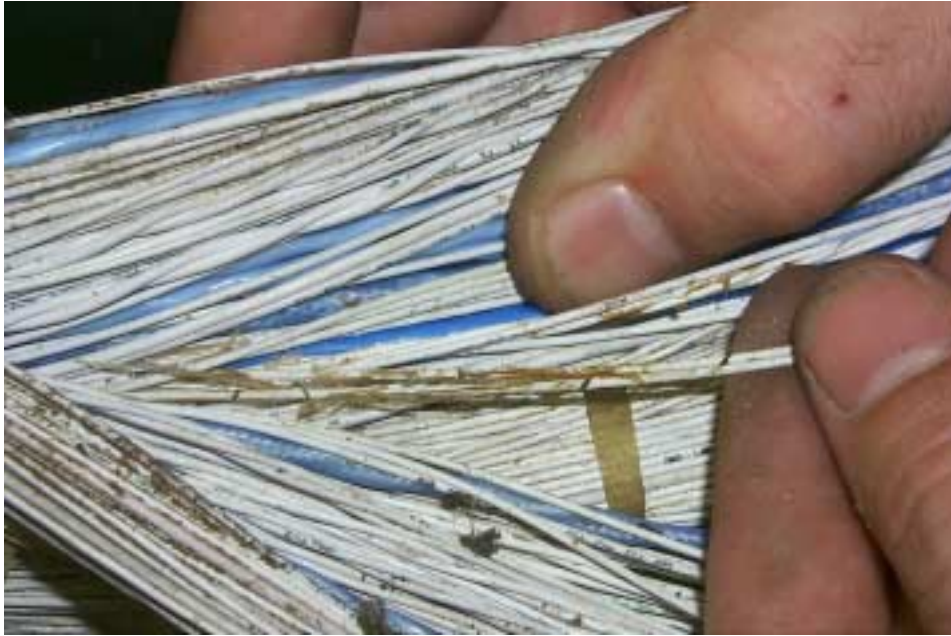
Laboratory Visual Inspection: Wires from nine sections of the aircraft were brought to the laboratories and studied. Eight sections appeared to be visually in the same condition. One section, the LCL-Midspan had a region that was atypical. This region was noticed because of the Lectromec DelTest™ which detected a breach in the insulation in this area (Figure 4-1).

Figure 4-1: A300 LCL Midspan (FEP, polyimide insulation) bundle with breached wire as found from DelTest™.

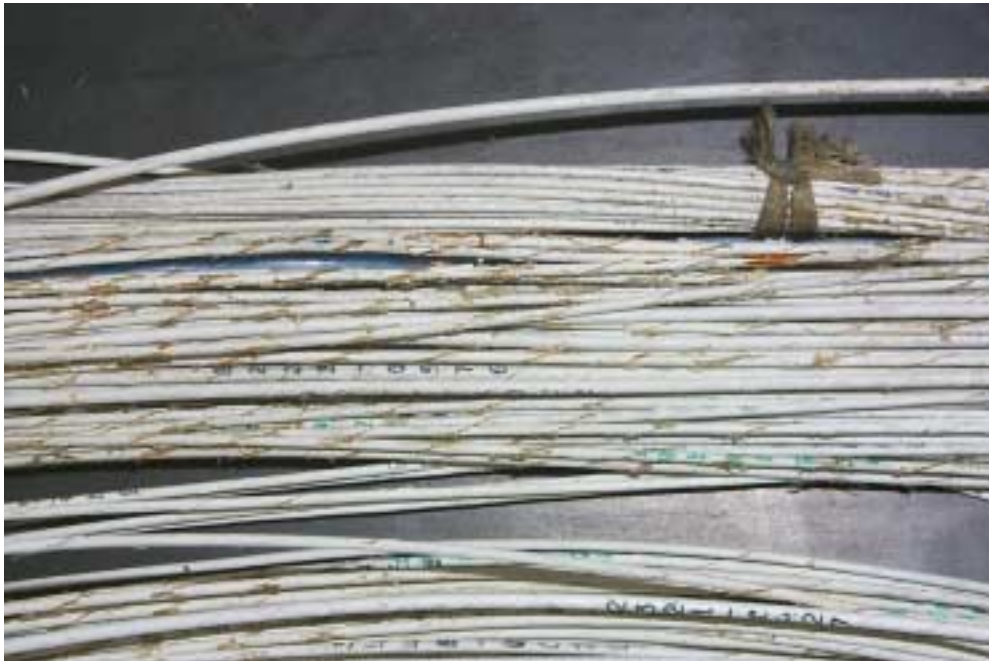
Closer investigation showed that clearly an event occurred in a localized section (ca. 30 cm of a ca. 2 meter bundle) of the bundle that affected many wires (Figure 4-2).

Figure 4-2: Picture of A300 LCL Midspan (FEP, polyimide) bundle in region where the topcoat is cracked and has unknown flakes on numerous wires.

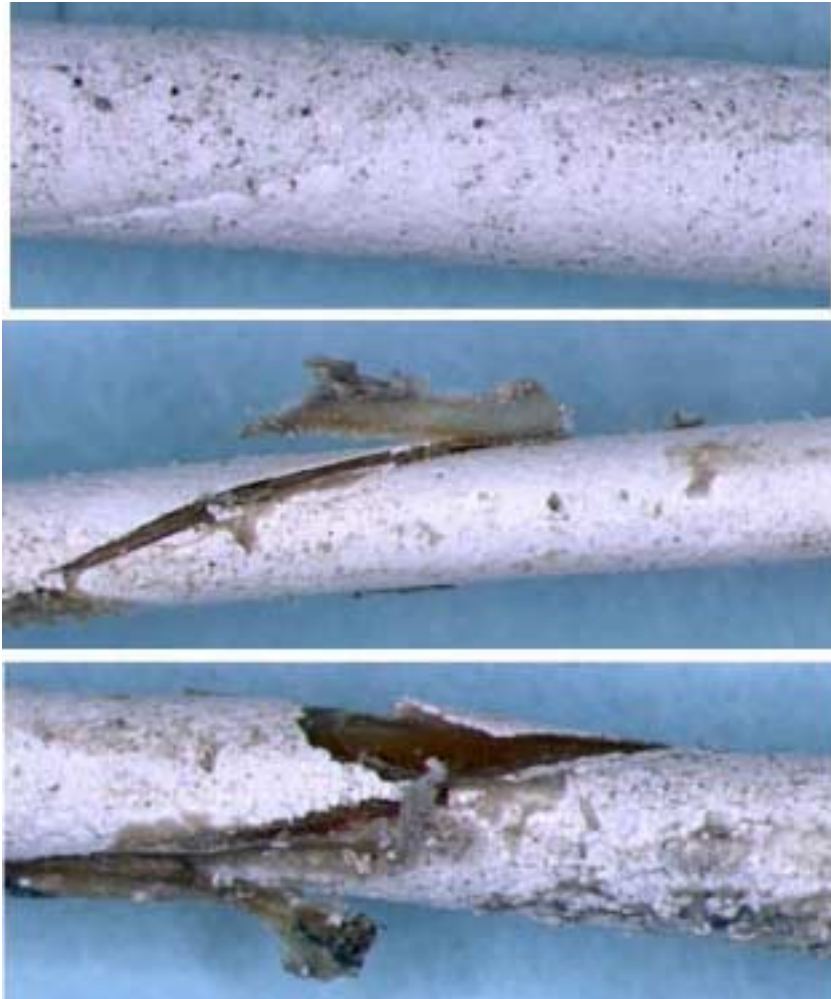
Closer examination under a microscope showed a dramatic difference between a typical piece of wire and the LCL Midspan area. It can be clearly seen that a typical section (Figure 4-3, upper),

and the LCL Midspan region under investigation (Figure 4-3, middle and lower), are very different.

Figure 4-3: Pictures of A300 wire insulation (FEP, polyimide); a typical section (top), and two areas in the LCL Midspan where the insulation is atypical (middle and bottom).

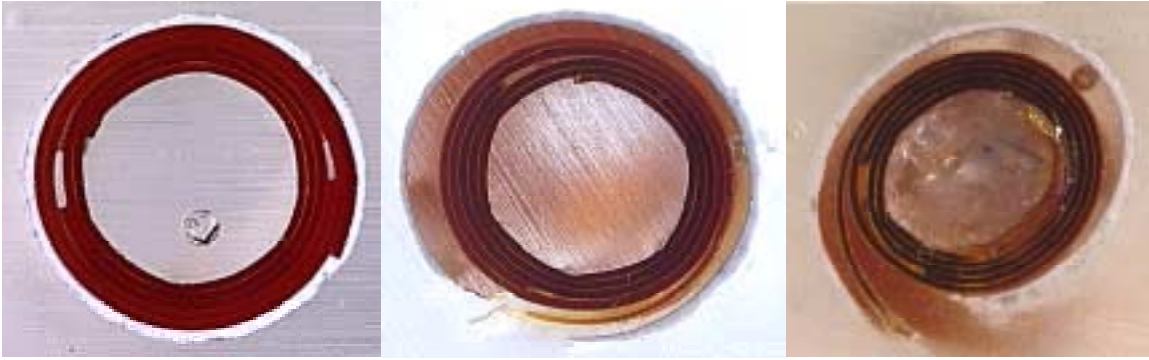
Figure 4-4: Cross section of A300 wires (FEP, polyimide) with conductor removed, from a typical section (left), and the atypical LCL Midspan (middle, right).

The typical section has the FEP coating still attached to the Kapton® (Figure 4-4, left). The atypical LCL Midspan section has the FEP completely detached from the Kapton®, and the Kapton® tape appears to be starting to unravel (Figure 4-4, middle and right).

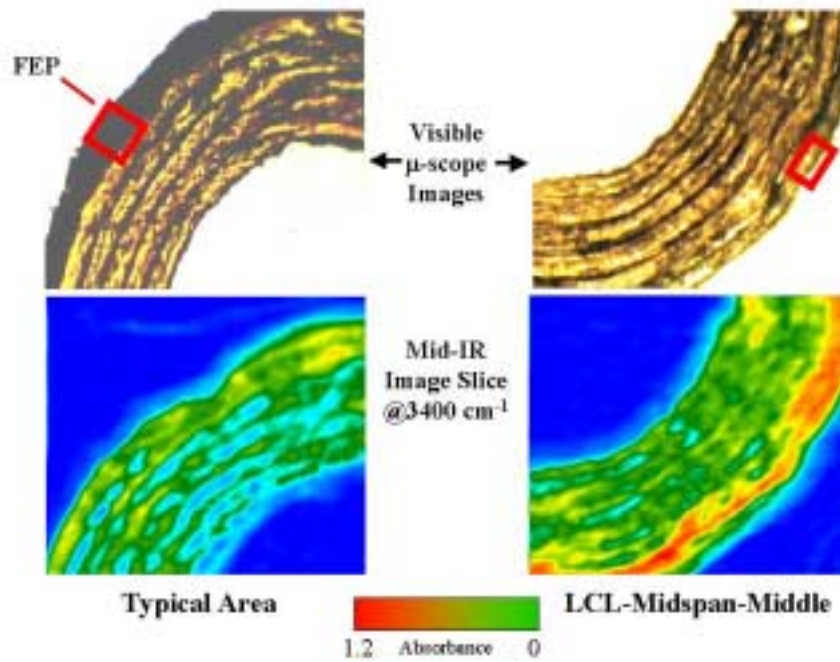
Infrared Spectroscopy: Infrared (IR) spectroscopy yielded some interesting results for this aircraft. When the IR spectrum of a typical cross section of insulation (with the conductor removed) was compared to the LCL-Midspan Middle, dramatic differences in the outer layers were observed (Figure 4-5).

Figure 4-5: IR spectra of the cross section of A300 (FEP, polyimide) wires. The top set is the visible images, and the bottom the IR spectra at 3400 cm⁻¹.

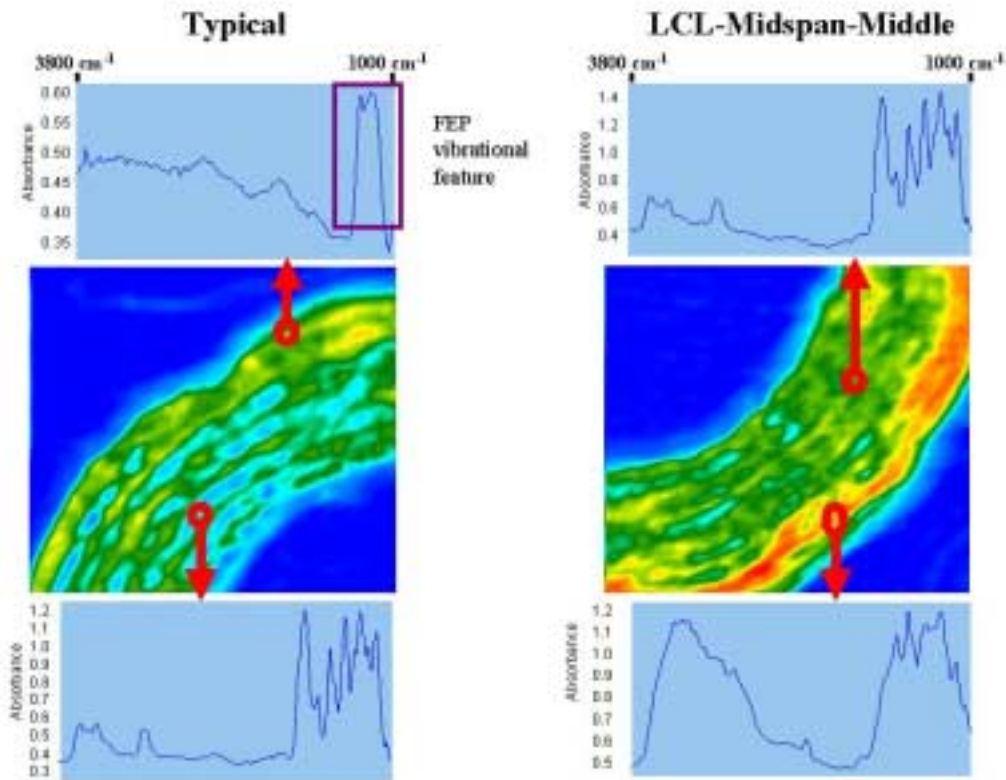
The IR spectrum also shows that while the outer layers of the insulation appear to be different, the inner layers have the same spectra (Figure 4-6).

Figure 4-6: IR spectrum showing the difference between the outer layers, and the similarity of the inner for a typical insulation (FEP, polyimide) and the A300 LCL-Midspan-Middle (FEP, polyimide).

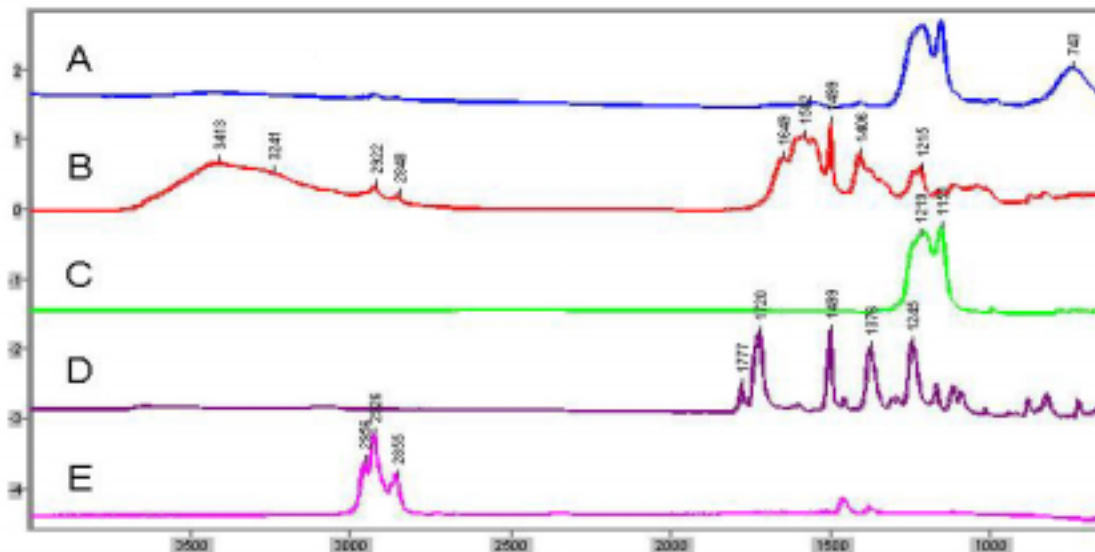
The IR spectrum of the flakes observed on the wire, of FEP, of Kapton®, and of a typical corrosion inhibitor compound are shown for comparison (Figure 4-7). It is important to note that the flakes appear not to be just a foreign compound or chemically changed insulation, but small particles of FEP (Figure 4-7, Spectrum A) are evident within the flakes.

Figure 4-7: IR spectra of the unknown flakes (spectra A and B), FEP (C), Kapton® (D), and a corrosion inhibitor compound (E).

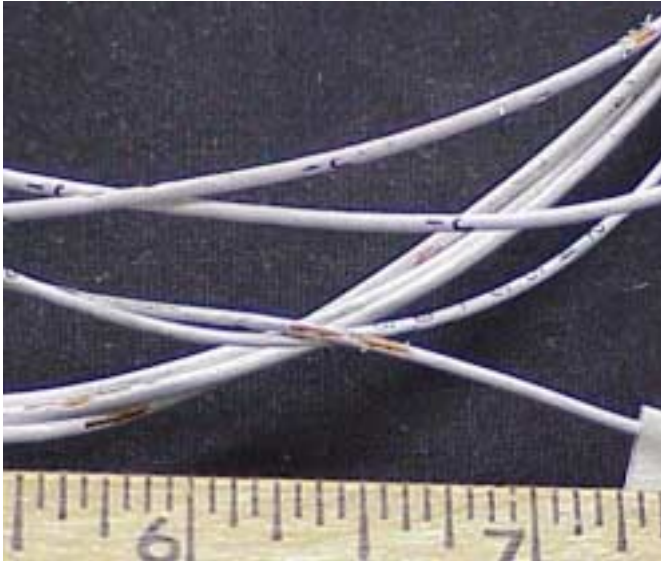
Raytheon Specimen Inspection: Only a few lengths of specimen were submitted for the A300 aircraft. Most of the wire was relatively clean, except for a black sticky substance on several of the specimens (ENS-2 C and D). All of the wire specimens exhibited abrasion of the outer coating, but none appeared to breach the inner layers of insulation, Figure 4-8. Some hot stamp marks protruded through the outer coating but did not appear to break the inner layers (CPT I and K, PSU-7 E and F), Figure 4-9. Later dielectric withstand proof testing confirmed dielectric failures on the marks of PSU-7 E specimen.

Figure 4-8: A-300, CPT I, PSU-6, PSU-7, (FEP, polyimide) abraded topcoat.

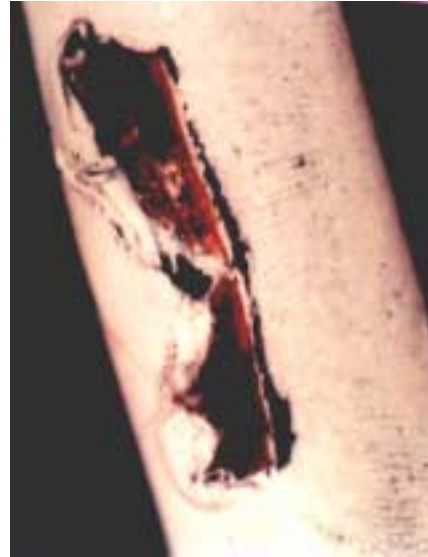
Figure 4-9: A-300, PSU-7 E, (FEP, polyimide) deep hot stamp marks along wire.

Wet Dielectric Withstand: Wire specimens tested to 2500 volts. One specimen failed the dielectric withstand proof test (PSU-7 E). This specimen failed by arcing through the insulation at one of the hot stamp marks after holding several hundred volts. This failure location was pulled out of the solution, and the specimen was rerun. Again, the specimen held several hundred volts, then failed at another hot stamp mark. This was repeated a third time with similar results. All other wire specimens passed the dielectric withstand test.

High Voltage Wet Dielectric Withstand: One specimen failed at 10,000 volts after 50 seconds (PSU-7). This failure occurred at a deep hot stamp mark.

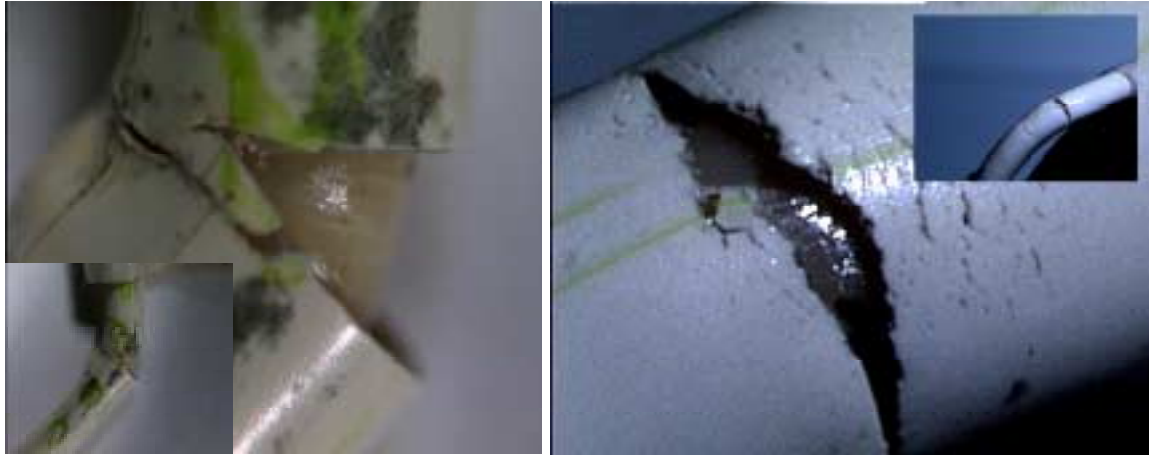
Mandrel Bend Results: One or two wires were removed at random from numerous sections of the aircraft (a total of 32 specimens). Most specimens showed no cracking, however, one section, ECH-2 Zone 10, cracked at the 2.5” diameter level (Figure 4-10, left); a second wire from the same bundle did not crack when tested all the way down to the 0.125” diameter.

Figure 4-10: 747 wire from section ECH-2 Zone 10 (alkene-imide polymer) showing cracked insulation from mandrel bend (left); non-aircraft wire (alkene-imide polymer) that also cracked (right).

It should also be noted that a similar wire manufactured in 1976 (provided by Raychem) and kept in a warehouse showed cracking at the 0.125" diameter level Figure 4-10, right).

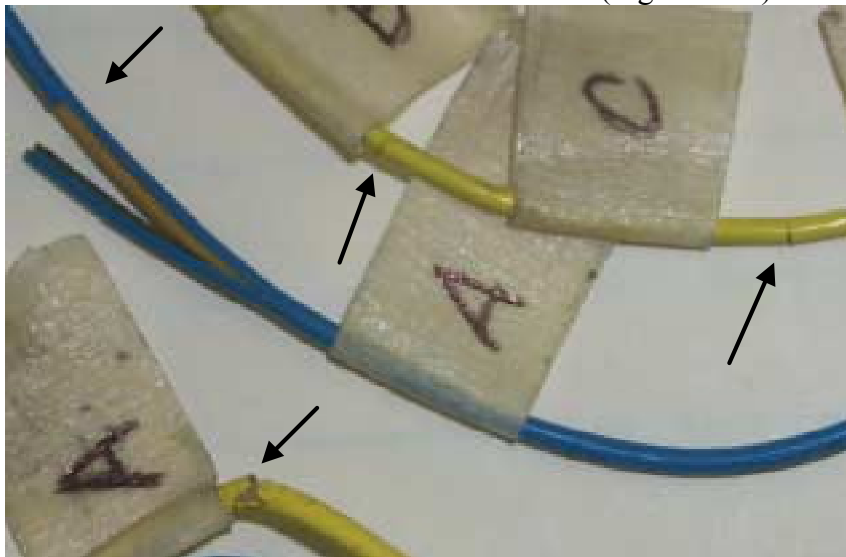
Wire coded 'W42A' corresponds to Raychem number 88A0131. It also corresponds to Boeing Spec. designation BMS 13-42A which is crosslinked alkene-imide polymer insulator on a tin coated copper conductor. This wire type was also examined via the mandrel bend technique. Of the 18 wires examined cracking was observed in section ENS-1 Zone 9 at the 0.5" diameter level, and ENL-1 Zone 8 at the 0.25" diameter level (Figure 4-11).

Figure 4-11: Boeing 747, ENS-1 Zone 9 (alkene-imide), top three arrows; and ENL-1 Zone 8 (alkene-imide) bottom arrow.

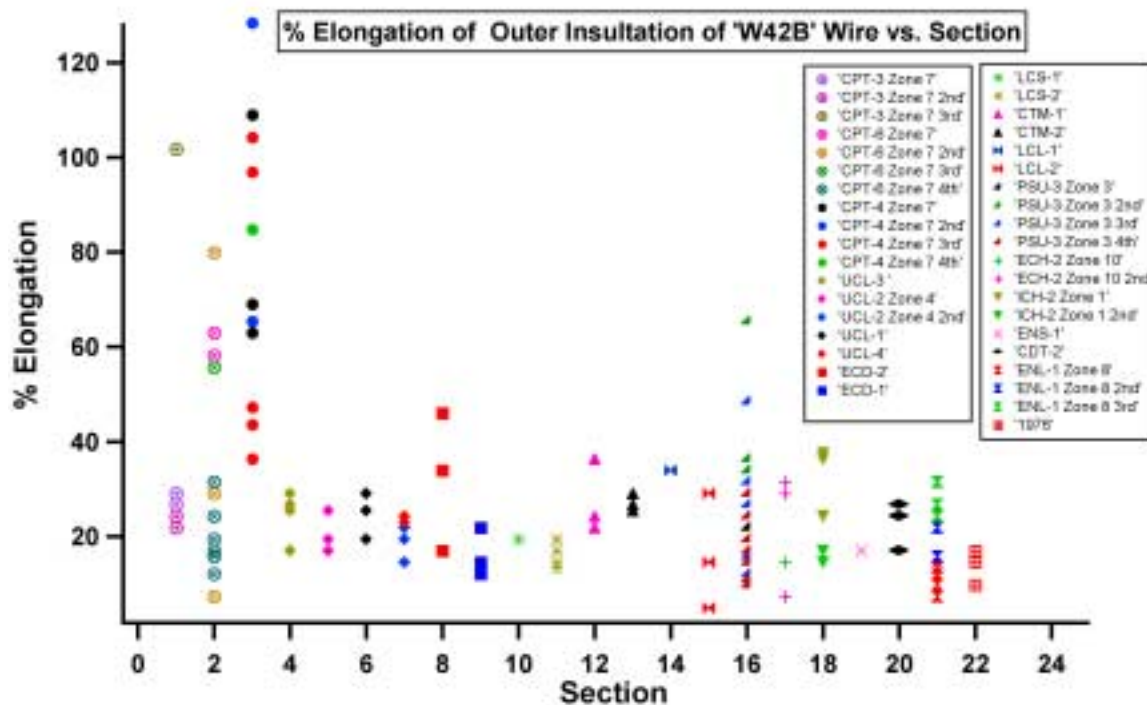
Tensile Elongation Results: This insulation is constructed of two parts, referred to as outer and inner. During the tensile test it was noted that in many cases the outer and inner layers broke at different times, thus they were analyzed as separate entities. Preliminary results indicate that the outer insulation in the section CPT-4 (rear) Zone 7 elongated farther than the other sections examined.

Figure 4-12: Elongation of the outer layer of wire W42B (alkene-imide) vs. section.

This hypothesis was supported by removing additional wires from a number of sections, including CPT-4 (rear) Zone 7, and repeating the experiment. The wires exhibited similar behavior (Figure 4-12). While there is scatter in the data, clearly one section (CPT-4) stands out. In general, the inner insulation either broke at the same time as the outer, or elongated much farther than the outer sections and did not display any noticeable difference from section to section due to the scatter.

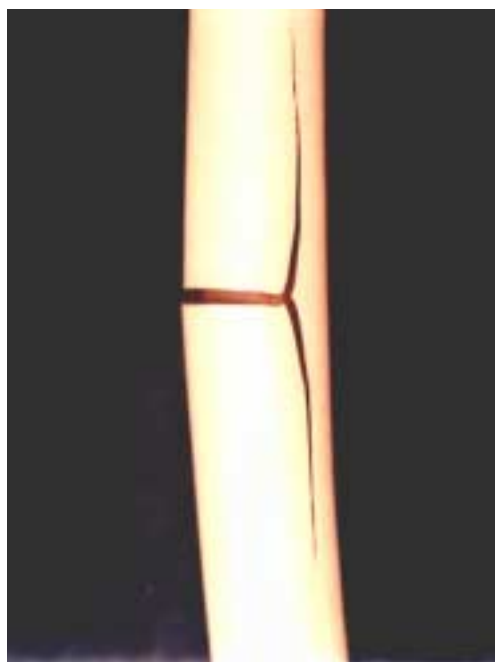
Raytheon Specimen Inspection: Wire specimens from several areas appeared relatively clean, while others were very dirty (ENS-1 Zone 9), or exhibited yellowish sticky residue (UCL-3 Zone 3, LCL-1 Zone 1, PSU-3 Zone 3), black sticky residue (ENL-1 Zone 8), or red sticky residue (ICH-1 Zone 2 and ICH-2 Zone 1). Small metal particles were found on several wire specimens (LCL-1 Zone 1, LCS-1 Zone 1). Additional physical damage found on the submitted wire specimens included light abrasions (CPT-4 Zone 7, LCS-1 Zone 1, and ICH-2 Zone 1), a deep gouge (ENL-1 Zone 8), nicks (ICH-1 Zone 2 and ICH-2 Zone 1), some of which are fairly deep, and tight kinks (ICH-2 Zone 1 and PSU-3 Zone 3). Several specimens exhibited short parallel tractor marks at regular intervals (ICH-1 Zone 2 and ICH-2 Zone 1), such as those left by marking machines in wiring assembly shops. Most hot stamp marks did not appear to penetrate the surface. One wire specimen was in particularly poor condition, with cracks in the insulation and exposed conductor, and evidence of carbonization (ENS-1, Zone 9), Figure 4-13 and Figure 4-14. A non-environmental splice was included as a part of one wire specimen (LCS-1 Zone 1.)

Figure 4-13: 747, ENS-1 Zone 9 (alkene-imide), cracked insulation

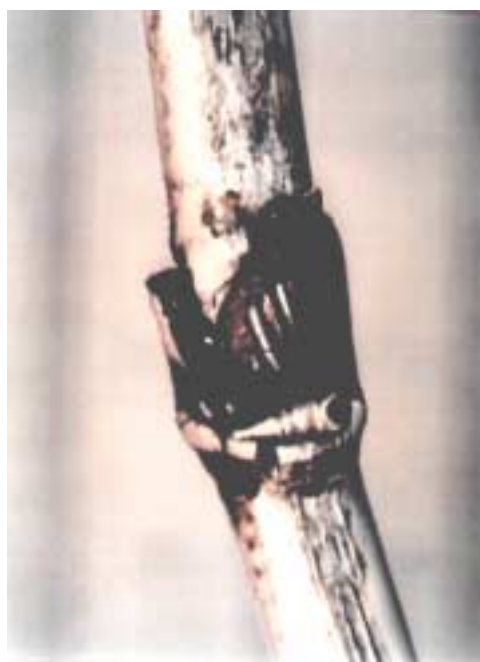
Figure 4-14: 747, ENS-1 Zone 9 (alkene-imide), exposed conductor.

Wet Dielectric Withstand: Two wire specimens failed the dielectric withstand proof test (CPT-4 Zone 7, ENS-1 Zone 9). The ENS-1 wire specimen was determined to have exposed conductor during visual inspection. All other specimens passed.

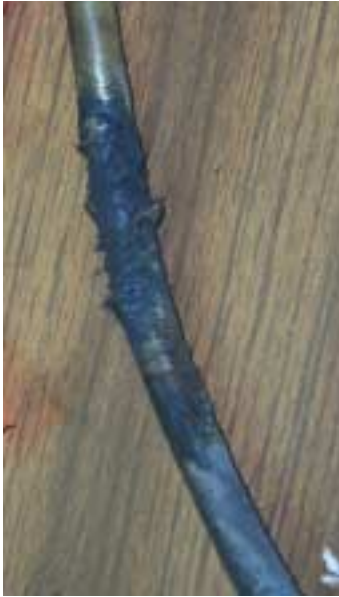
Figure 4-15: Burnt DC-9 (EPF) wire found by the DelTest™, that was inside a steel conduit and visually impossible to detect.

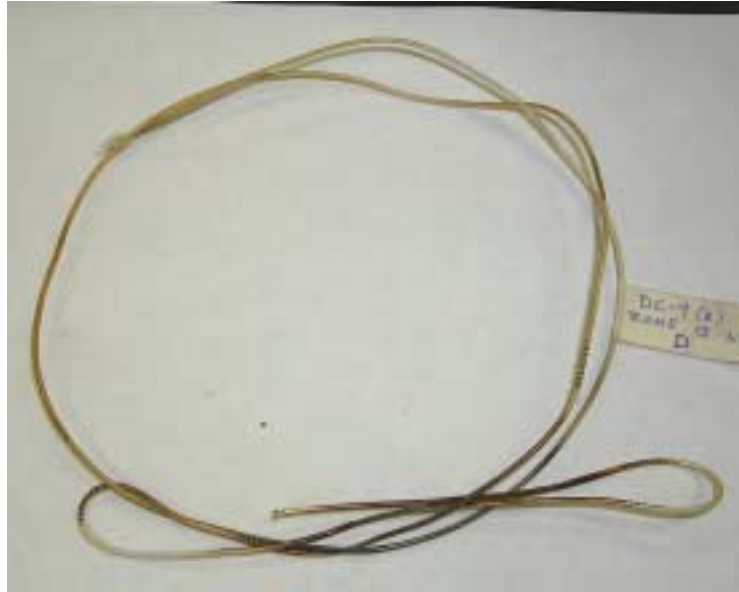
Figure 4-16: Wire from DC-9 (2) Zone 13 LWT (Nylon/Glass/PVC) that clearly demonstrates the range of conditions observed.

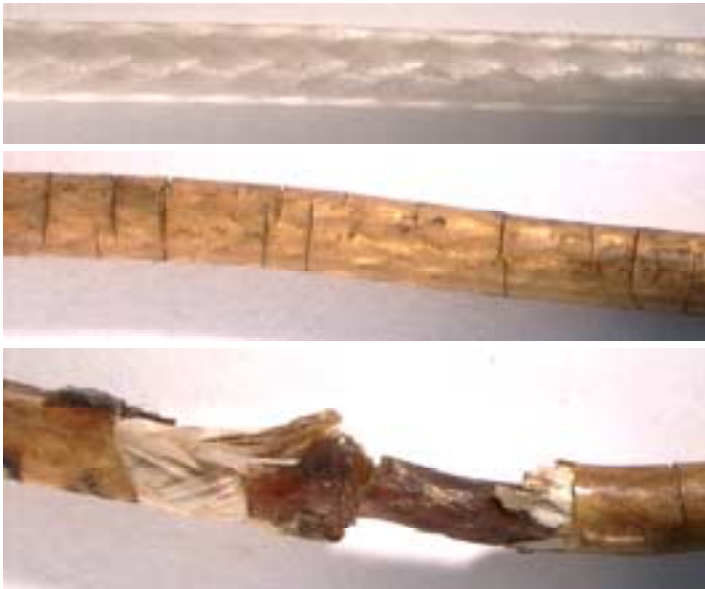
The wires from sections LH tail cone, RH tail cone, Zone 13 LWT, TH tail cone, and ENL showed signs of damage and/or degradation (Figure 4-17).

Figure 4-17: Multiple pictures (all at 3.5X) of the same DC-9 (2) wire from section ENL (Nylon/Glass/PVC) illustrating the range of conditions observed.

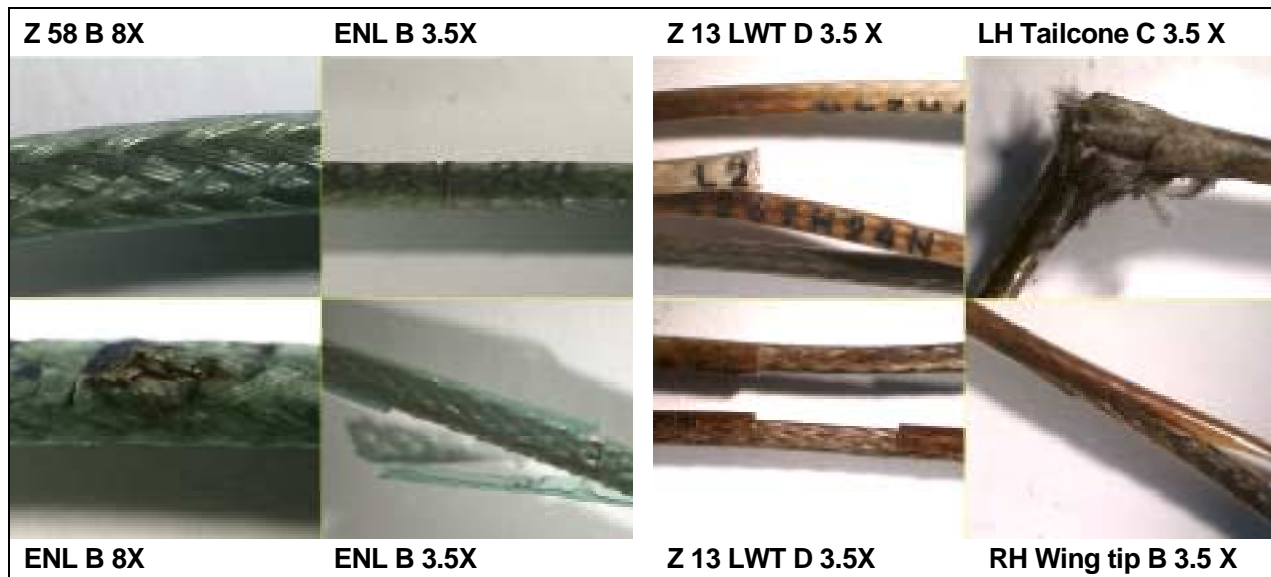
These sections had regions that were charred/burnt, cracked, and embrittled; in some instances parts of the outer insulation were missing (Figure 4-18). Numerous events were found that appeared at first glance to be thermal events. Upon closer examination it was realized that many events that appeared to be thermal could be breached nylon with contaminants fiberglass (and or nylon/PVC). Due to this fact the reader is cautioned not to draw any conclusions about the causes of events based on a visual examination as they can be misleading.

Figure 4-18: Variety of wires in various conditions all from the DC-9 (2) (Nylon/Glass/PVC).

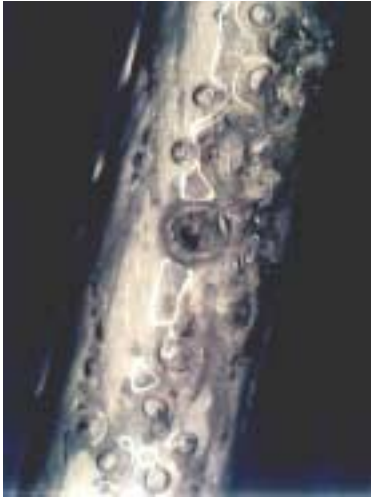
Figure 4-19: DC-9-2, CDT-E (Nylon/Glass/PVC) bubbles in outer insulation

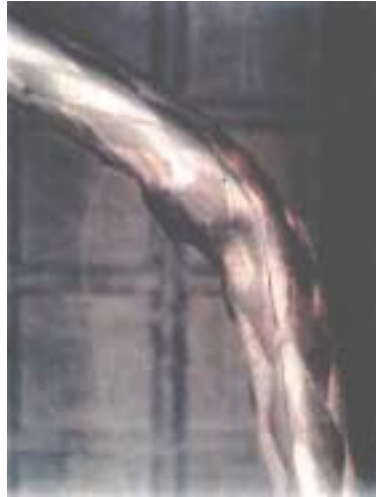
Figure 4-20: DC-9-2, UCL-G (Nylon/Glass/PVC) kink in wire specimen.

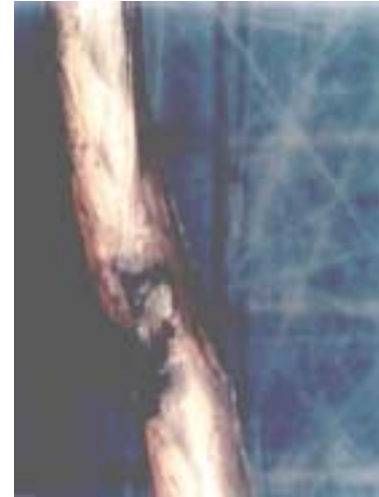
Figure 4-21: DC-9-2, Zone-14 F, (Nylon/Glass/PVC) pinched wire specimen.

Wrap: Wrap back procedure was used with oven aging at 95°C for 24 hours. Two specimens exhibited cracking in the outer nylon insulation following arcing (UCL-H and Zone-14 F). All specimens passed the dielectric withstand proof test. Samples with exposed conductor were not tested since they were cracked and had already failed the dielectric withstand voltage proof test.

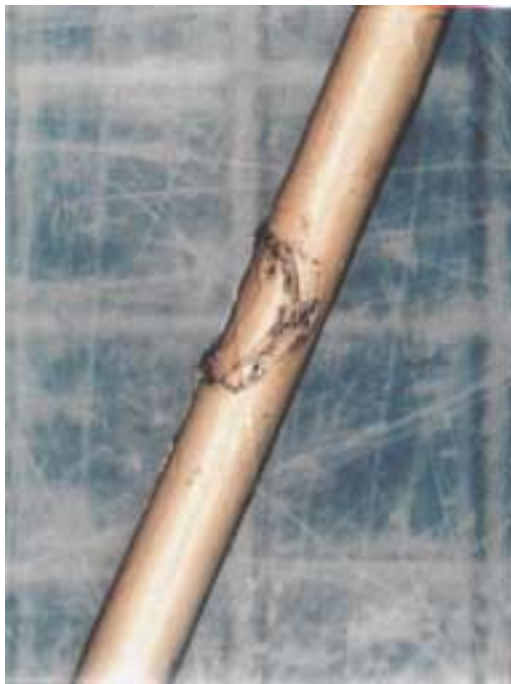
Specimen Inspection: Various wire types were present: mainly polyimide tape wrapped constructions to Lockheed specifications, but also including small quantities of polyimide tape wrapped wire with Airbus markings (UCL), MIL-W-22759/16 ethylene-tetrafluoroethylene insulated wire, and possibly polytetrafluoroethylene insulated wire. One non-environmental splice was present (PSU D), and one environmentally sealed splice was found in-line of one power feeder cable (IPF B.) The splice connected 2 gauge copper conductor to 0 gauge aluminum conductor. Some wire specimens were extremely dirty and sticky from fluid contamination (ENL, EPF). Wires from one specimen were covered with a black tacky substance (CTM and CTM-2). Small metallic particles were found in the dirt between the members of a twisted triple (ICH). The insulation of one specimen was blistered and contained deep hot stamp marks (LCL), Figure 4-23 and Figure 4-24.

Figure 4-23: L-1011, LCL-L (polyimide) blister along wire.

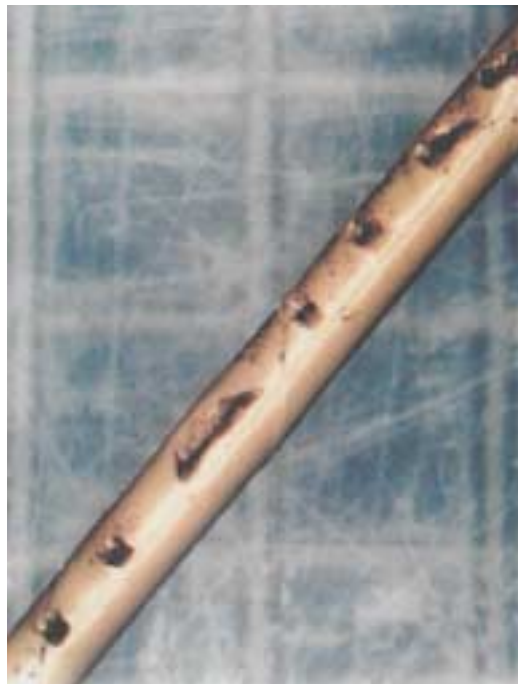
Figure 4-24: L-1011, LCL-L (polyimide) deep hot stamp marks.
