Chapter 6: Analysis of Wire Degradation

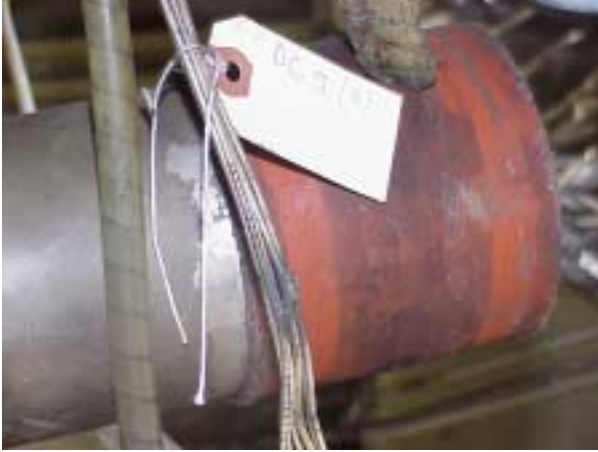
2. DC-9 Wire is Spiral Wrap: along vertical braces to either side of the aft stair there are small wire bundles protected by spiral wrap. Upon removal of the spiral wrap one inspector noticed that the several of the wires were burnt from apparent wire-to-wire arcing. (The exterior of the spiral wrap was not scorched.) The arcing may have been the result of chafing induced by the spiral wrap.

DC-9 Tail Cone Burnt Wires

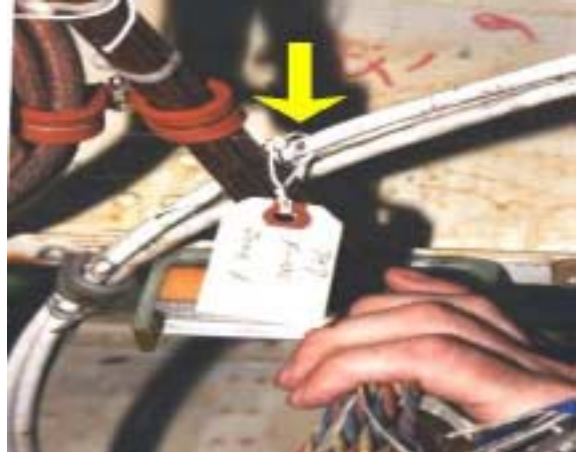
5. 747 Power Feeder Cable Chaffing: An inspector noticed that one two power feeder cables crossing each other at a 60 degree angle was chaffed through to the core. The other power feeder cable did not appear damaged. The cables had no mechanical fastener at or near the point of crossing and contact. The chaffing was most probably caused by vibration and relative motion during operation of the aircraft.

747 Power feeder chaffing

Boeing is aware that relative motion between wires with differing insulation abrasion characteristics will result in wear to one or both of the affected wires. For this reason Boeing recommends that relative motion between the wires be eliminated or, if that is not possible, installation of protection between the wires. In-service experience has indicated that wrapping of wire bundles and proper clamping at the wire bundle attachment points prevents relative wire motion between different wire specifications within the same wire bundle. In the case of two different wires or wire bundles crossing at an angle on the same plane, as in the case of the Roswell 747, Boeing specifies the installation of abrasion protection on one of the wire bundles and tying of the bundles together to protect against abrasion and to reduce relative motion. Boeing does not believe that the Roswell 747 exhibited the concern of insulation wear as a result of installing different wire specifications within the same wire bundle. We believe that the use of present installation practices as outlined in the SWPM would have prevented the noted chafing.

Finally, Boeing wire feeder installation practices results in separation of the individual feeder phases, but there are no special requirements for separation of individual power feeder wire bundles. Boeing applies similar best practices to all systems, regardless of the system power requirements, to prevent any arcing event. We do so because any arcing event on any system, regardless of the resultant damage to adjacent systems, is to be prevented.

Given our in-service experience, recommended wire bundle installation practices, proper maintenance of that installation, and the ability to identify a similar discrepancy through visual examination, we believe that a similar installation on other airplanes is unlikely. However, to ensure that operators are aware that this condition was noted on one airplane, and to alert them to the need to follow proper installation practices to prevent similar occurrences in the future, we will prepare an operator notification outlining the nature of the discovery which will include information concerning the age of the airplane, the systems involved, and details of our recommended wire installation practices. Release of this information will take the form of a Fleet Team Digest article and occur in the 1QTR 2001.

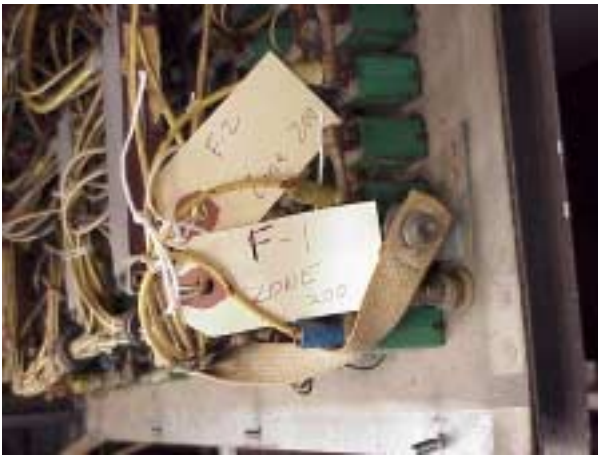
7. L1011 Circuit Breaker Panel Wiring: An inspector noticed that two wires leading to circuit breakers had traumatic damage that probably resulted from the wire's being pinched between the swing-down panel and adjacent fixed panel. Over-length wire or improper routing is the most likely cause of the damage.

L1011 Circuit Breaker Panel

1. Service Bulletin 093-24-109 address's circuit breaker wiring that was reported to be chafing against a circuit breaker terminal. This SB can be revised to include the same solution for all wiring contained within circuit breaker panels, provide inspection criteria and instructions for repair and securing of the wiring.
2. Create a Service Bulletin that address's the specific discrepancy and provides a solution.

Lockheed Martin will review the previously mentioned options and take the appropriate action necessary to ensure that each operator is aware of the RSC and its hazard potential.

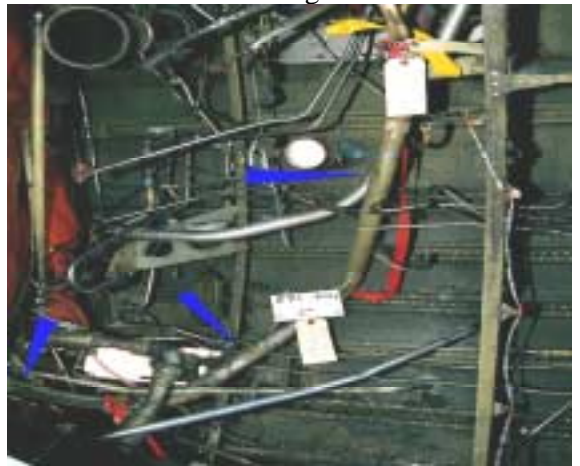
4. DC-9 Power Feeder Cable in Conduit: Lectromec testing identified a breached power feeder cable within a conduit. The cable was not visually inspectable. Subsequent laboratory analysis found a charred area on the cable indicating electrical shorting or severe overheating.

DC-9 Tail Cone, Right Hand Side (blue arrows indicate conduit)

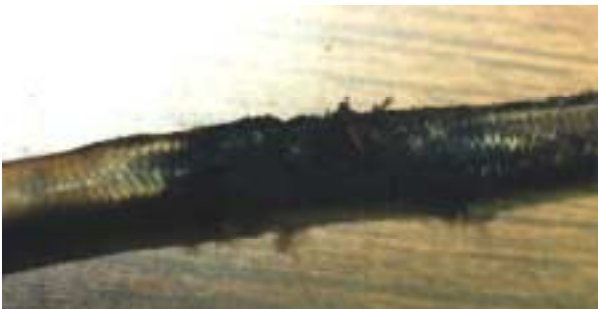
DC-9 Tail Cone Power Feeder removed from conduit

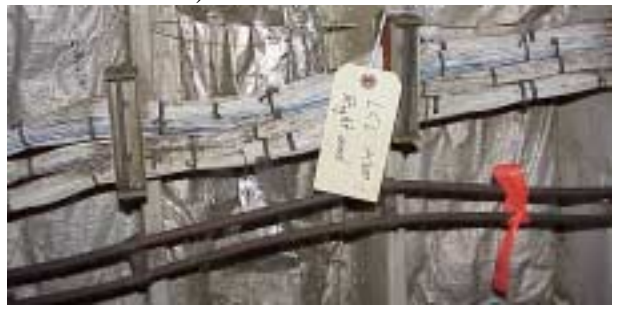
6. A300 Polyimide Delamination: Apparent localized delamination of several wires was discovered during laboratory visual examination. Though there was no field indication on the specimen, other wires in the area were noted as being contaminated with toilet fluid. One of these wires was identified by Lectromec's field and subsequent lab testing as being breached to the conductor. Laboratory analysis of the bundle showed that several wires had partially delaminated and degraded polyimide insulation. (See Appendix 4.2.1)

A300 EE Bay, LCL specimen where delamination was discovered

Laboratory analysis of the atypical insulation condition of the wires of this localised portion confirmed a beginning of delamination (1/3) due to hydrolysis of the first layer of the outer polyimide tape (double-wrap insulation type, 50% overlap), the rest of the insulation remaining intact. Insulation resistance test of the other wire with same visual condition confirmed the integrity of the electrical characteristics of the wire. From these results, a delamination has not been demonstrated as the root cause for the breaches and other initial local condition could also be suspected (e.g. cut, mechanical trauma).

Though the exact contaminant was not evidenced anymore on the bundle (and this situation has stopped the hydrolysis phenomenon at some stage), laboratory analysis, and knowledge on polyimide material behaviour, suggests that polyimide hydrolysis was caused by the presence of a strong fluid base (pH>11) remaining enough time in the localised portion to initiate the degradation.

In order to collect more detailed data for a full assessment of the service condition of the area, Airbus has already enhanced its aging inspection procedure in the form of a specific inspection task to be carried out during the forthcoming Airbus aging in-service aircraft inspections, to be carried out during year 2001 campaign.

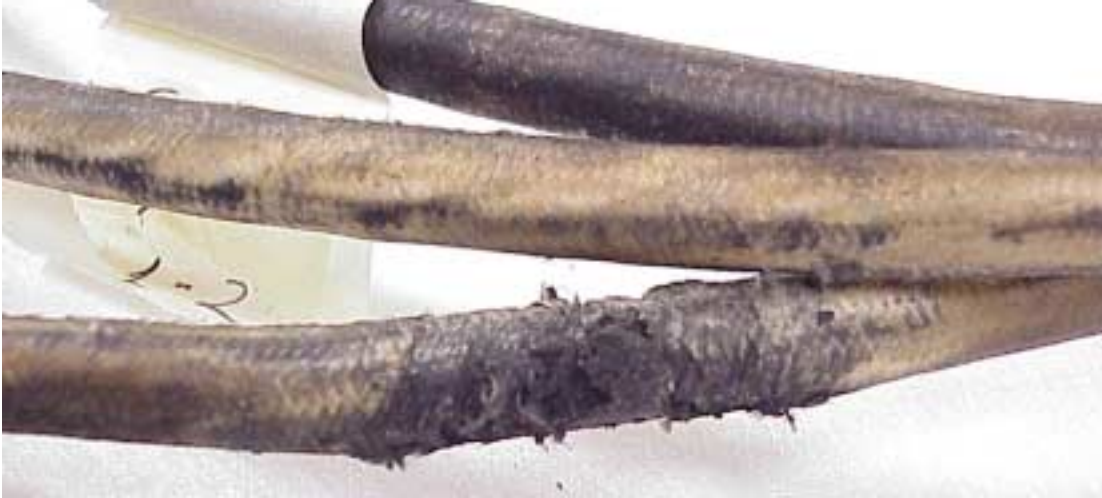
Figure 1: Sample 1-4

Sample 1-4 (SRC #4): Sample 1 consisted of 3 aluminum power feeder cables routed through a metallic conduit. Visual inspection of Sample 1-4 suggested the damage observed was due to abrasion. Further inspection of Sample 1-4 found black deposits on the wire exterior. These marks, when aligned with correspondingly shaped marks in the conduit, placed the wire damage zone over a corresponding abraded area located on a bend inside the conduit. It was noted that the black deposits exhibited a gummy consistency rather than the powdery consistency expected of an aluminum oxide, and that the deposits only seemed to appear where the wire and conduit were in contact. The remainder of the tube remained relatively clean.

The outer braid layer was stripped from the wire. Inspection confirmed braid permeation by a gummy residue consistent with that found on the inside of the conduit. The insulation layer under the braid layer corresponding to the abraded zone was missing and black, gummy deposits were noted on the inner braid visible through this gap in the missing insulation. In the adjacent areas where the outer insulation was not completely worn, the corresponding remaining insulation had a slightly darker color and exhibited a soft, rubbery texture unlike the outer insulation observed away from the damaged area.

It can be deduced that the metallic tube was heated beyond the temperature rating of the cables. At the point where the cables were riding against the conduit, a condition, which began to degrade the cable's insulation occurred.

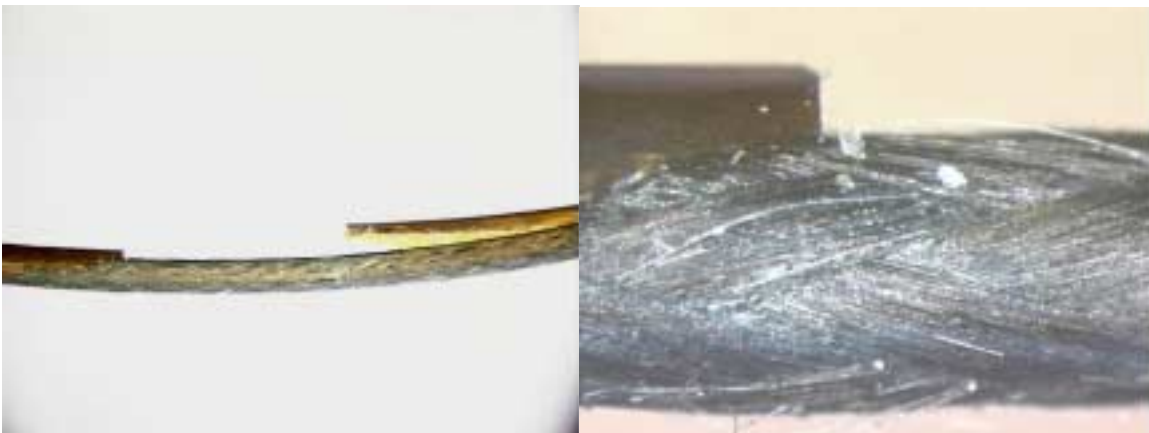
Figure 2: Sample 4-6

Sample 4-6 (SRC #2): Much of Sample 4-6 was discolored by what appeared to be thermal damage. While the exterior insulation had cracked and spalled in two separate locations, the underlying braid, which was badly discolored, appeared to be intact. Further investigation proved that the primary insulation layer (PVC) was damaged by the external heat source enough to prevent the sample from passing the established wet dielectric test.(Figure 2).

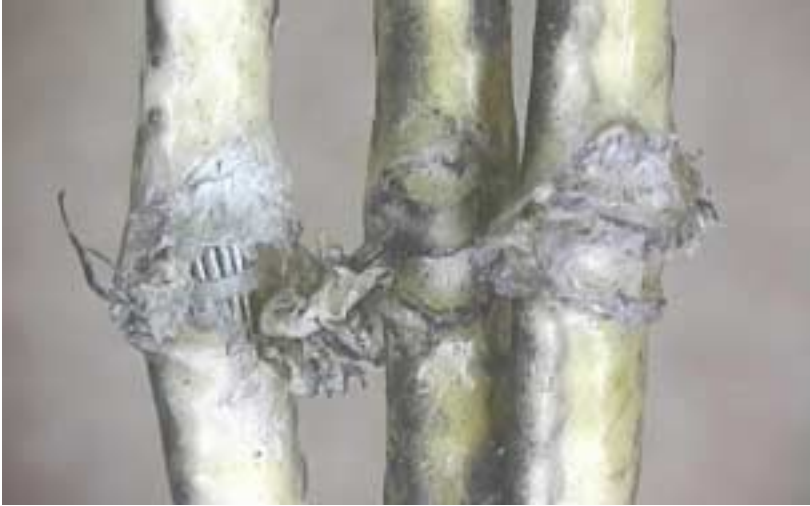
Figure 3: Sample 5-2 (L)

Sample 5-2 (not a SRC item): Sample 5 consisted of three wires tied in a bundle with a plastic strap. Inspection found that all three wires had suffered mechanical damage as shown in Figure 3: . Sample 5-2 was the only one of the three wires that displayed a breach to the bare conductor. Failure of the wire is attributed to this breach.

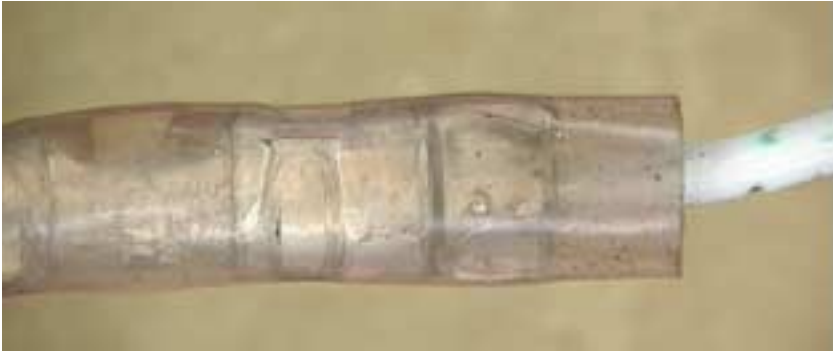
Figure 4: Sample 8-1

Sample 8-1 (SRC #3): Sample 8-1 wiring appeared undamaged, however the wire did contain the mechanical splice seen in Figure 4. Excessive current leakage was found at this unsealed splice.

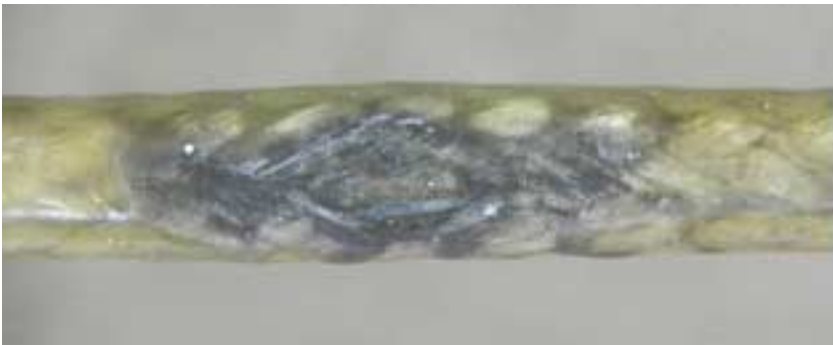
Figure 5: Sample 8-9

Sample 8-9 (SRC #3): Sample 8-9 did exhibit some surface damage (Figure 5). Experience with the previous samples suggests that this damage was probably insufficient to cause excessive current leakage. Like Sample 8-1 this wire contained a mechanical splice similar to that in Figure 4. The splice was found to be the source of excessive current leakage.
