# **TWA 800**

# **Accident Overview**

**Michael Collins**  
**Fuel Tank Safety Program Manager**  
**Transport Standards Staff, ANM-112**  
**[michael.collins@faa.gov](mailto:michael.collins@faa.gov)**

**November 5, 2001**

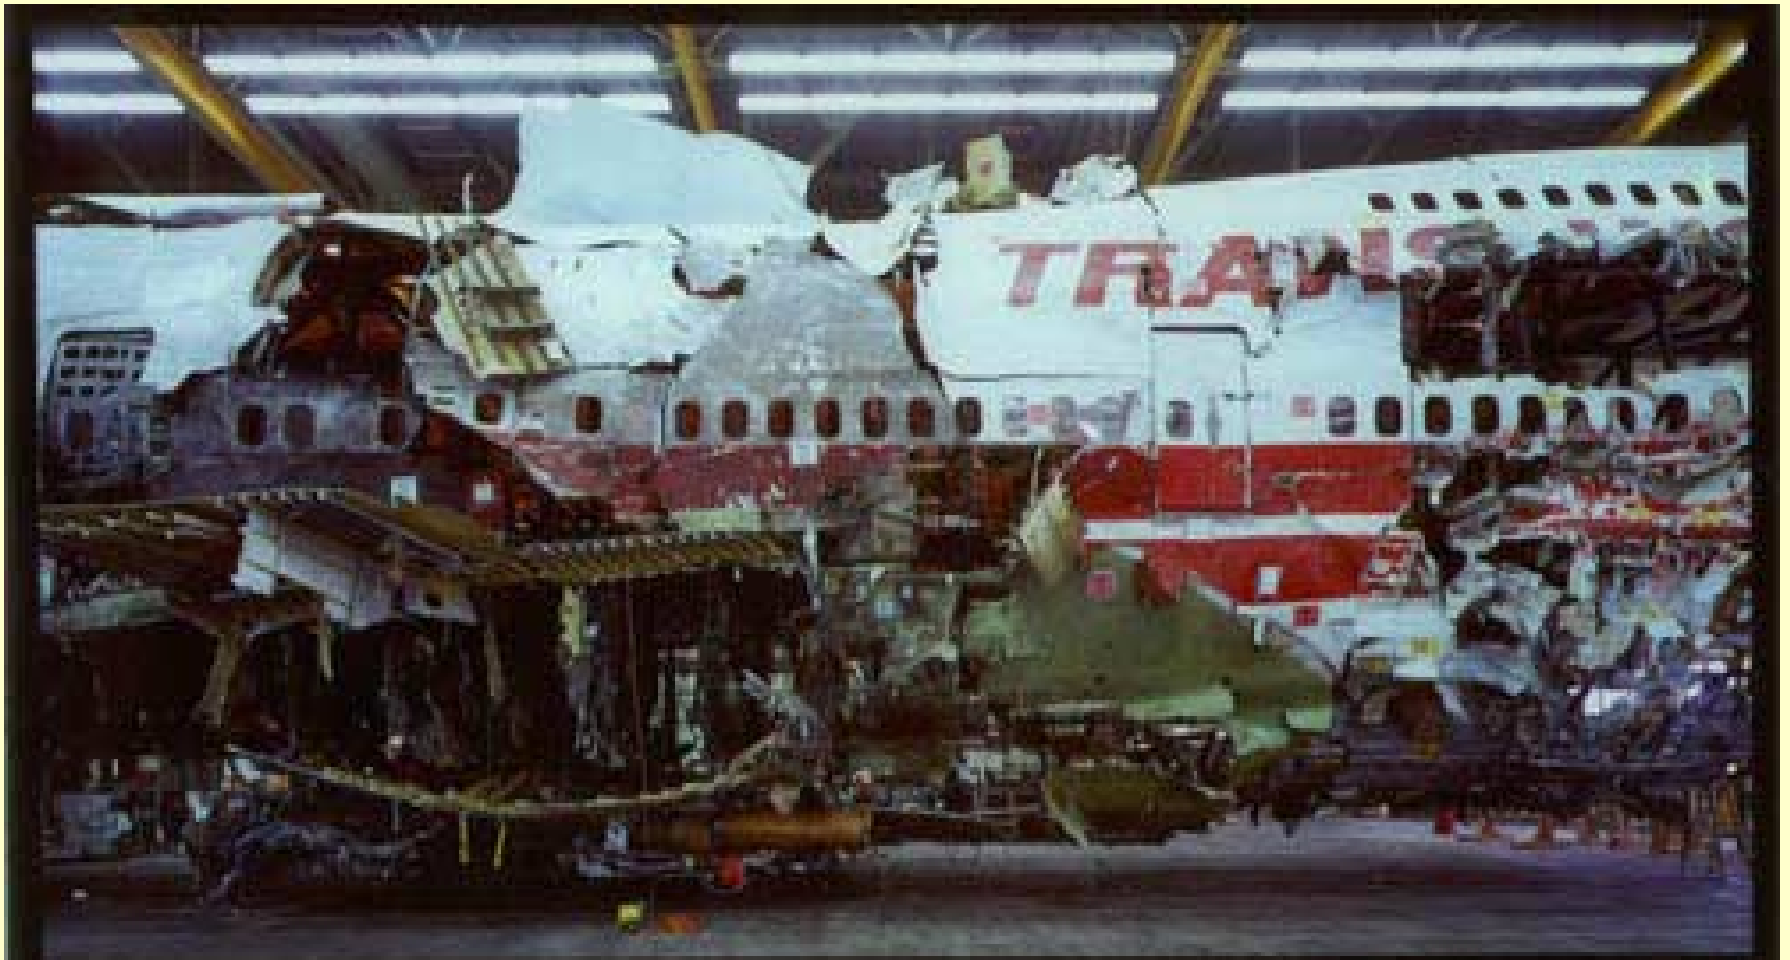
- Three Dimension reconstruction from station 520 to station 1640
- Reconstruction contains 876 pieces of the wreckage
- Reconstruction weighs 60,000 lbs
- Reconstruction took 2 months to build
